Stability of slope Along Abha-Darb Road

Abstract— The study work comprises of the stability analysis of Slope Along Abha-Darb Road, Asir Region, Kingdom of Saudi Arabia. The area is vulnerable to landslide to avoid this problem. Geotechnical study was carried out along the road cut slopes to determine the various properties of soil mass. Which act as input parameters for the numerical simulation of Slope (Fast Lagrangian Analysis of Continua). The result is checked for displacements and FOS. The result shows that the slope is unstable showing circular failure at the upper height and is quite stable at the lower height of the slope.

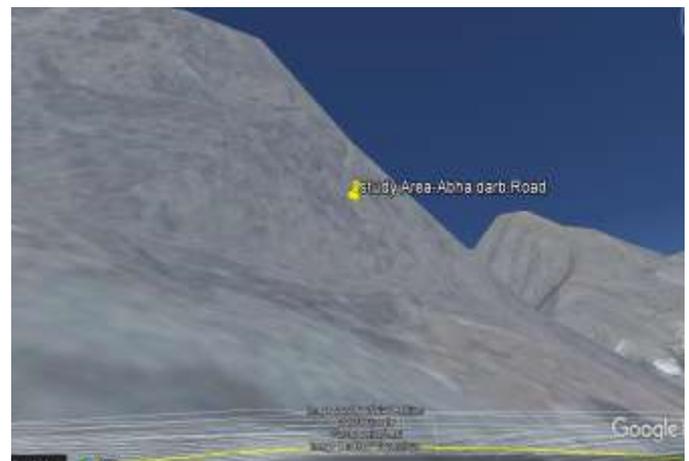
Fig.1 Site of Study Area

The project work was carried out on Slope 20 km from Abha towards Darb. For Geotechnical study, the soil sample is collected from the location $18^{\circ}4'6.8''N, 42^{\circ}30'18.6''E$. The area is particularly taken into study work as it is regularly damaged and there is huge probability of landslide occurrence in future which can cause loss of human lives and property.

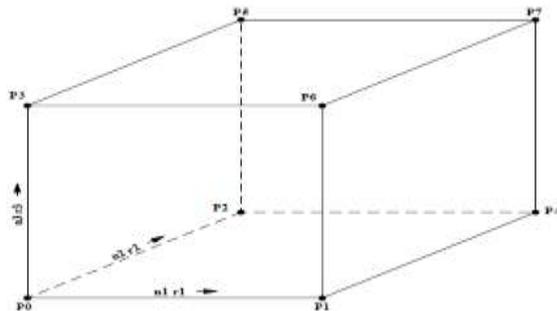
Fig. 3 Brick Element

Three dimensional nonlinear analyses were carried out by making use of finite difference code FLAC3D to study the effects of static response of Slope. FLAC3D contains an automatic 3D grid generator in which grids are created by manipulating and connecting pre-defined shapes such as brick, wedge, pyramid and cylinder. In the present study, the geometry of the soil domain is created using no of brick shape element Figure shows the element numbering for a brick shape used for creating the soil domain. In this figure, p0, p1...p7 specify the reference (corner) points of the shapes, n1, n2 and n3 specify the number of zone in their respective directions and r1, r2 and r3 specify ratios that is used to space zones with increasing or decreasing geometric ratio. Similarly figure shows the wedge element which is used to create toe of the hill.

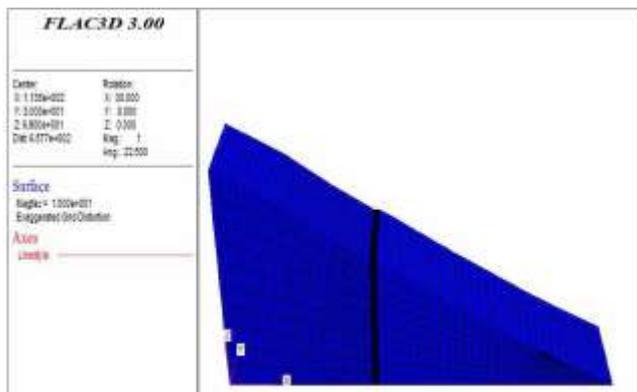
Fig. 5 Model of Slope

The displacement in x direction is found to be 0.183m while the displacement in y direction is found to be negligible in the power of 10⁻⁵ m and in z direction it is found to be 0.095 m. respectively

The whole grid is discretized into 6540 number of zones and 8482 number of grid points.

For the slope stability analysis, the boundary conditions of slope model were as follows: At the base of the grid all movements are restrained. The planes at X = 0 m can freely move in Y and Z directions and not in the X direction. In the same way, the planes Y= 0 and Y= 5m are free to move in X and Z directions but not in the Y direction.

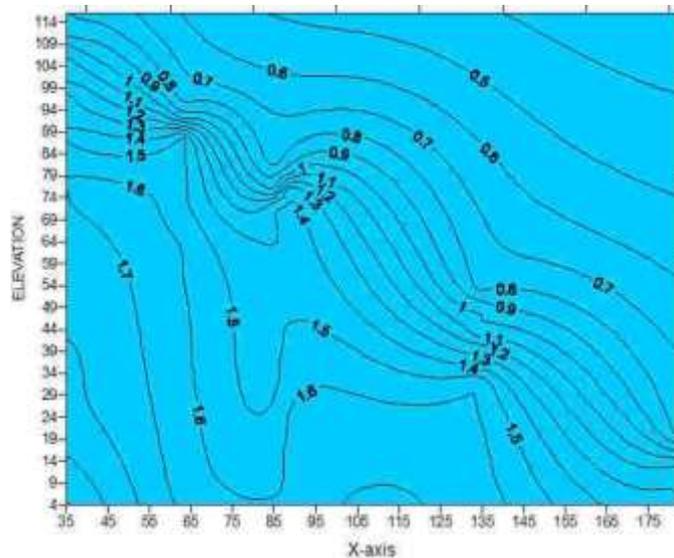
Fig. 5 Factor of safety wrt X-axis and Elevation

The factor of safety with respect to Elevation and Height which is shown in the form of contour line is plotted which is showing that slope is unstable at higher height and is very stable at lower height. Moreover the factor of safety contour line is showing trends of circular failure.

The study work analyses the stability of slope along Abha Darb Road Asir region which are often prone to landslide. The slope was investigated for the stability using three dimensional finite difference codes. The specific maximum displacement computed in the slope in X – direction is 0.18295 m in static case the specific maximum displacement computed in the slope in Z – direction is 0.094675 m in static case Thus we can definitely conceive that the slope is undergoing large deformations. The result of factors of safety of the slope at different location confirms the unstability of slope of slope which is showing the pattern of circular slope failure. Keeping in mind the shortcomings of the present study, extensive study should be made on the study area to know about the properties of whole mass. In our case whole
